Security: MFP and how it can affect your throughput

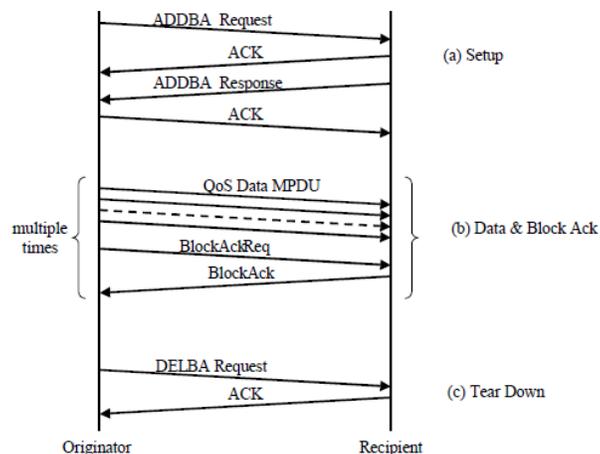
Figure 1

We started comparing packet capture from a case where the box was able to do around 650Mbps TCP on DL with capture from a case where the box was only able to do around 30Mbps. At this point we could tell what the reason for this drop was. It was aggregation. In the low throughput case, there were no BA frames. All packets were sent as single MPDUs frames rather being sent as A-MPDUs frames. Now the only thing left was to know why this was happening. To explain this, let's take a quick look how at how A-MPDU works, first the AP wins time slot, then it sends an ADDBA request to the client, the client acknowledges it and sends back an ADDBA response. Now that the BA frame work has been established the AP can send all MPDUs as an A-MPDU and the client can acknowledge all of them by a BA frame at the end of the transmission. Figure-1 shows how the process works.
